# New Afton Convergence Monitoring and Rehabilitation Planning in the B3 Footprint

**ABSTRACT:** New Afton's B3 block cave footprint has been in steady state production since 2022. During mining, the production footprint is subject to changing stresses that have been observed to cause squeezing and convergence of the drift profile at drawpoints and extraction drives. This can present challenges to the mining operations in terms of drift stability and accessibility of the footprint for equipment. Robust geotechnical monitoring practices have been developed to address this. Convergence is monitored using periodic visual inspections, LiDAR scanning, and multi-point borehole extensometers. These geotechnical monitoring activities generate data that requires interpretation and review during rehabilitation planning. Geotechnical monitoring data is assessed before, during, and after rehabilitation to understand the effectiveness of rehabilitation activities. This paper discusses two practical examples of New Afton's convergence monitoring and rehabilitation practices in the B3 footprint with the objective of documenting the importance of timely and well-planned rehabilitation in achievin

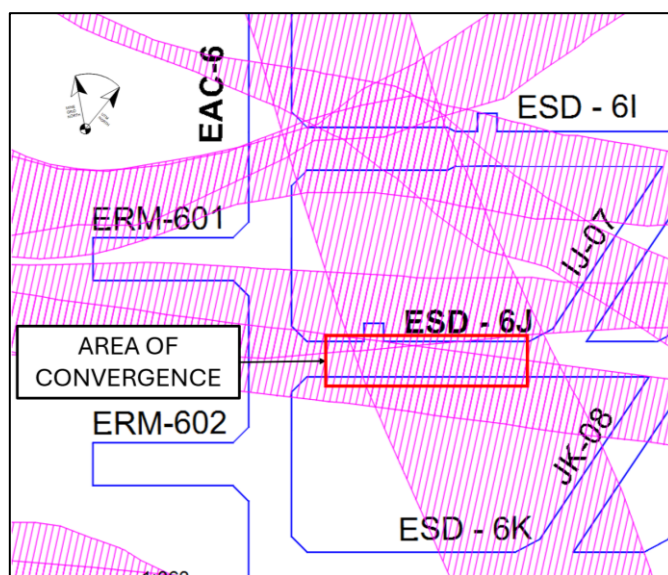
In October of 2019, ESD-6J was developed. Face mapping confirmed the presence of steeply dipping faults comprised of heterogeneous, highly altered, and highly sheared material. These faults and their orientations are

Figure 6. Highlighted location of ESD-6J convergence. Overlaid are fault projections originally obtained from drillhole data and refined with face mapping data. Each hatched area is an individual fault. In the area of convergence two faults run parallel with ESD-6J drive direction and one runs perpendicular to the drive. The combined shearing, alteration, and joint infilling of the three faults has weakened the entrance of the extraction drive more than if only a single fault were present.

shown in Figure 6. The transition from EAC-6 into ESD-6J had an irregular development profile, with the largest amount of overbreak in the back. In January of 2021 prefabricated rebar cages were secured to the back using 47mm splitsets loaded with #7 forged head resin rebar (known as hybrid bolts). The rebar cages were then sprayed into place to reduce drift size and increase support pressure.

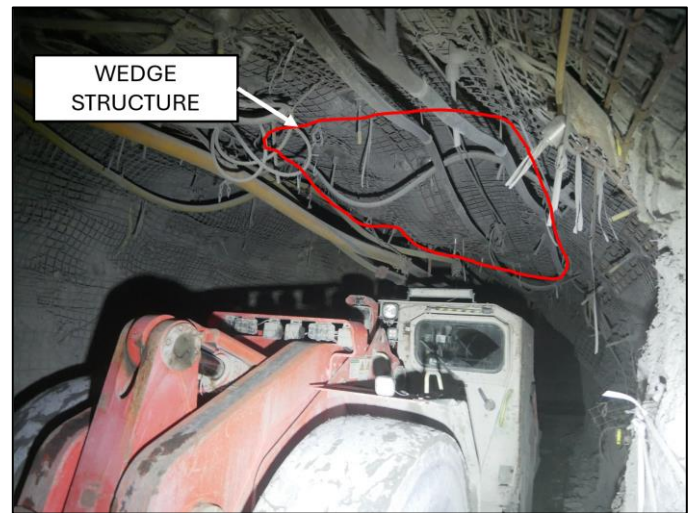
From March 2022 to May 2022, drift convergence continued with reduced movement in the back. Convergence rates increased in May of 2022, and due to the faulted nature of the ground, it is believed that preferential sliding planes developed, forming a pronounced wedge-like structure in the back as shown in Figure 7.

Figure 7. Entrance of ESD-6J Drive looking west towards EAC-6, showing limited vertical access for production equipment – November 2022. “Wedge” structure is highlighted for clarity. The concrete floor at the entrance of ESD-6J drive had been removed already at this point to allow for increased vertical clearance for production equipment.

Scaling and re-supporting of the back wedge was completed July 2023. The rehabilitation targeted only the wedge that had formed and leaving any areas that were intact and supported alone. This wedge was approximately 10-12 meters in length with the drive and spanned most of the width across the approximately 4 m wide drive. Approximately one meter of vertical height was gained through the scaling process, with the rehabilitation crew aiming to keep a smooth and arched profile in the back through the scaling and re-supporting process. Smaller wall sections that had been damaged through convergence and subsequent equipment damage from the tighter confines were scaled and re-supported as well. The floor was repoured, and production access was restored to the drive.

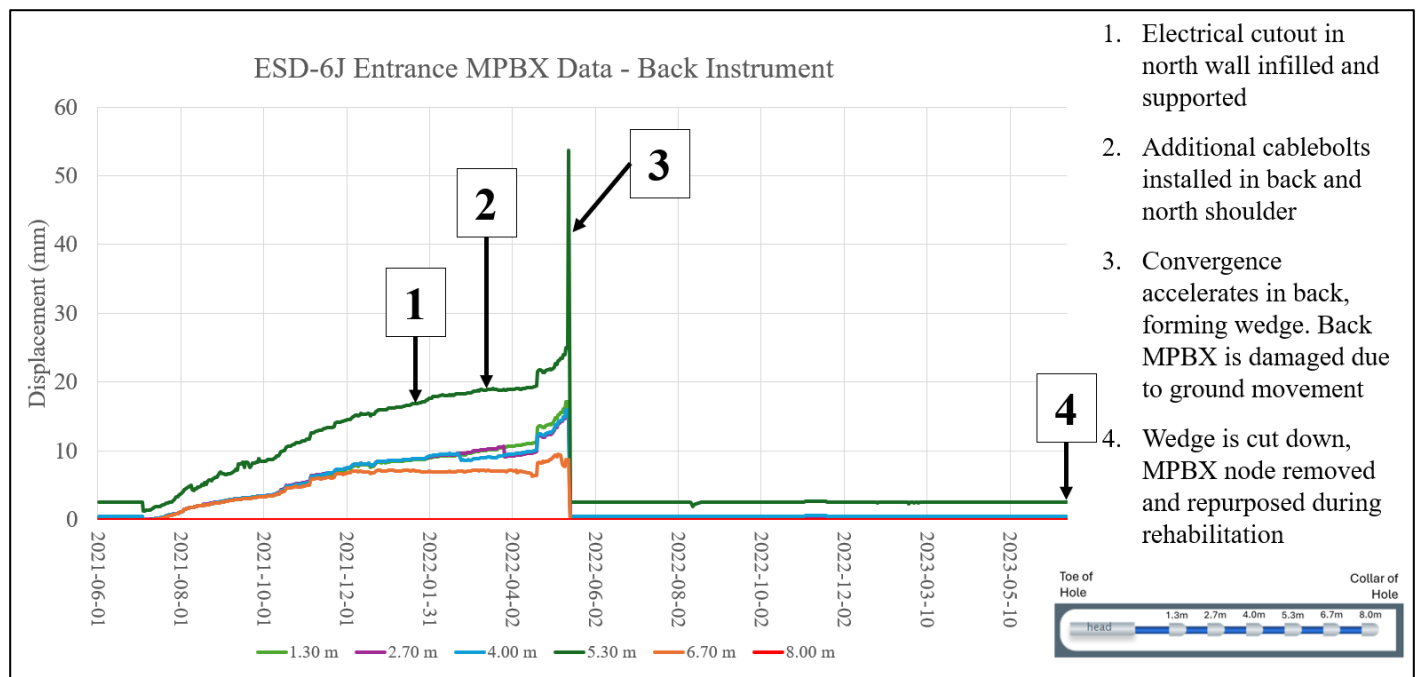
- The nearest instruments in the north and south walls both showed a typical pattern of progressive, stress-driven bulking near the skin of the drift profile with relatively low depth of yield (<2.7 m) and low, steady rates of deformation (<1 mm per day).
- The nearest instrument in the back showed deeper seated yield up to 6.7 m depth and irregular movement rates of up to 1 to 2 mm per day.
- The nearest instrument in the back was damaged due to ground movement in May 2022.

Figure 8. MPBX data from back instrument located closest to convergence area in ESD-6J. Reference image of MPBX positioning from Mine Design Technologies, 2018.

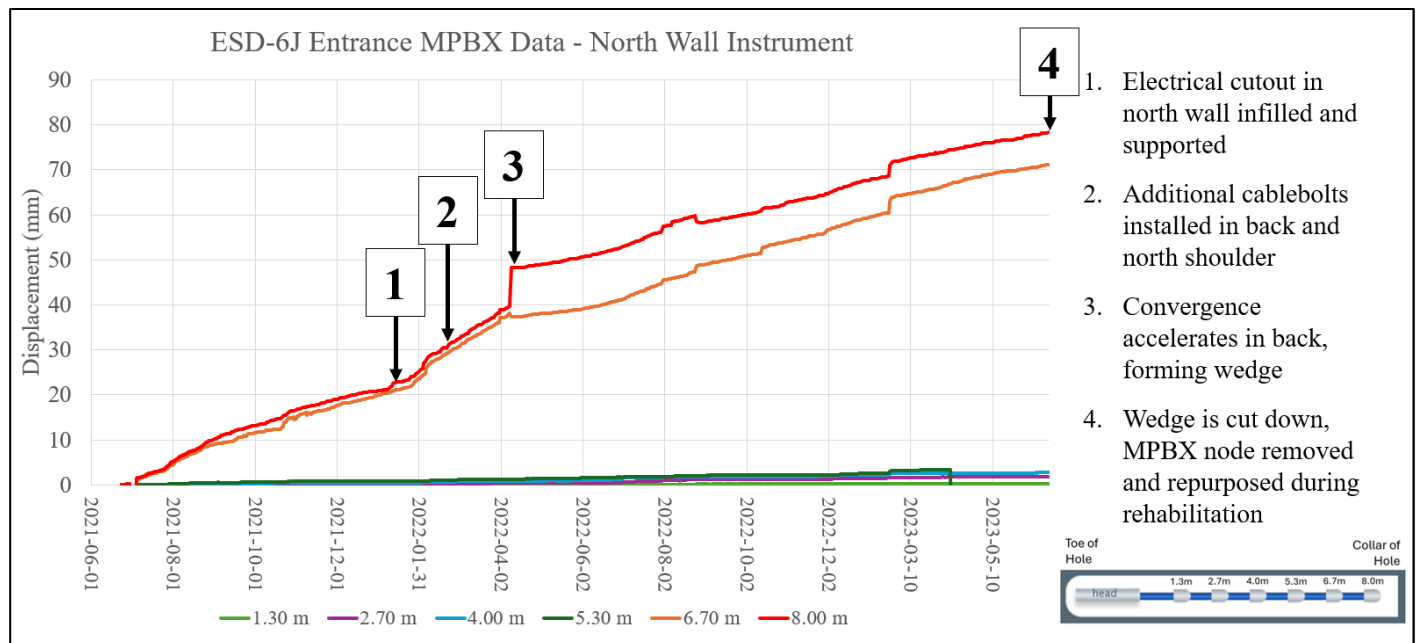
Figure 9. MPBX data from northern wall instrument located closest to convergence area in ESD-6J. Reference image of MPBX positioning from Mine Design Technologies, 2018.

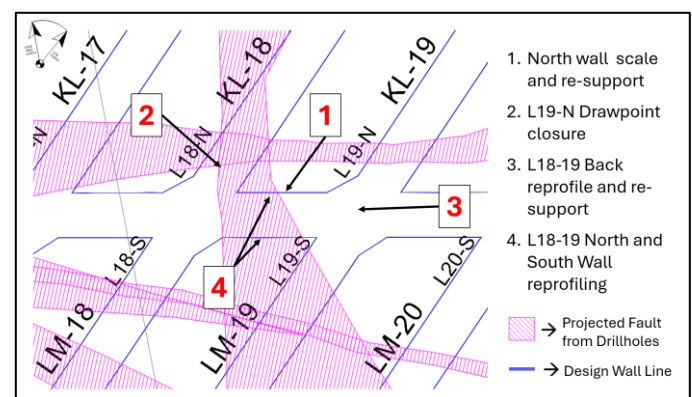
Figure 10. Map of completed rehabilitation in ESD-6L due to convergence. Projected faults from drillhole interpretation are overlaid.

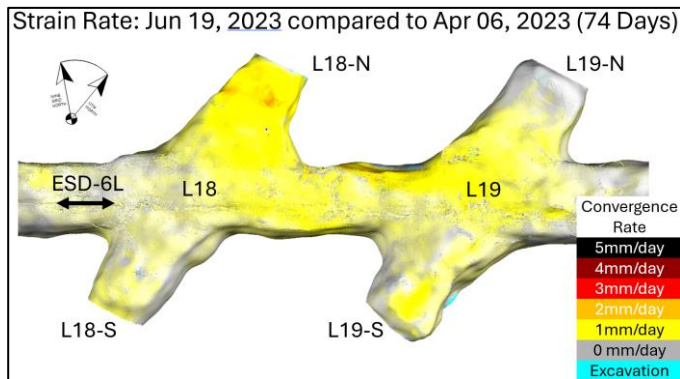
Mine operations made multiple efforts with drill and blast techniques and mechanical rock breaking equipment to dislodge the oversized material, but the drawbell had issues keeping material flowing due to the coarse fragmentation. Cave loading from the consolidated muck pile began to concentrate in the adjacent drawpoint brow and pillars. Damage became visible in late December 2022 and into January 2023. From this initial weakening and mobilization of already poor ground, the movement continued over a period of several months at a rate of 1-2 mm per day until rehabilitation efforts were required in September 2023. A portion of this time of movement can be seen in Figure 11.

Figure 11: Example ESD-6L convergence scan showing April to June 2023 strain rates.

In September of 2023 a reprofiling of the north wall of the strike drive between L18 and L19 drawpoints was completed. The wall had deteriorated to the point where shotcrete was slabbing off the wall and visible shoulder shearing was occurring. The wall was reprofiled, with new short and long support installed. Ground movement continued after this rehabilitation, extending into the surrounding back and opposite south wall of the extraction drive.

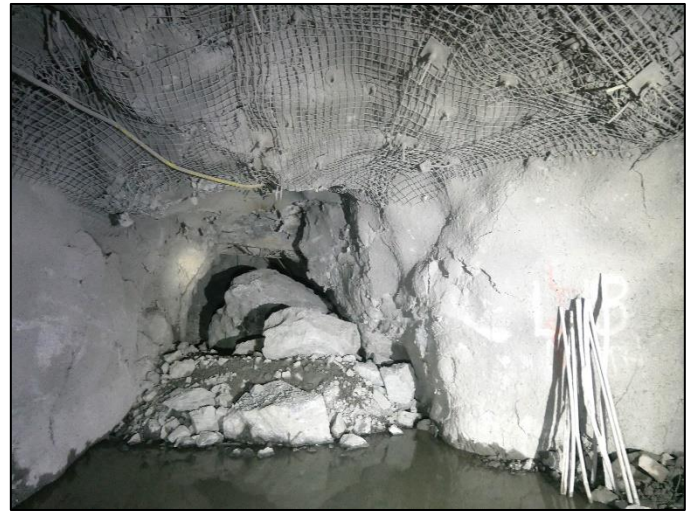
L18-N drawpoint continued to see damage, reaching strain rates of 4-5 mm per day. Severe damage in the walls and brow of the drawpoint was observed as shown in Figure 12. During October 2023, the L18-N drawpoint was stuffed with oversize material and sprayed closed with fibre-reinforced shotcrete. 47mm Splitsets loaded with #7 forged head resin rebar (known as hybrid bolts) and OSRO straps were installed to add support pressure.

Figure 12. L18-N drawpoint in October 2023 prior to being closed. Ground movement and resultant damage can be seen in both walls and the back, with the right wall encroaching on the drawpoint opening.

Drain holes were drilled through the shotcrete to eliminate any potential fluid pressure buildup.

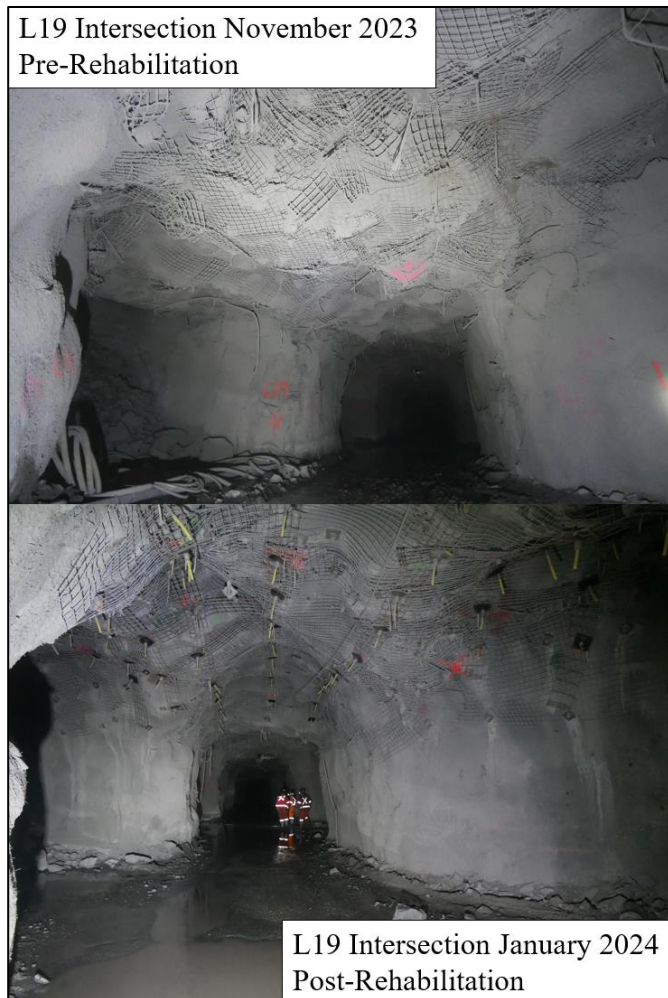
In November 2023, the L19 intersection and the surrounding area required reprofiling and re-supporting of the back. The continued stress on the area heavily affected the already hummocky back profile, damaging and breaking up both the shotcrete and rock behind. A decision was made to scale, reprofile, and re-support the area. This involved scaling out the damaged shotcrete and rock from almost the entire back of the intersection and into a portion of the adjacent drawpoint entrances. Short support included new fibrecrete and hybrid bolts, and 9 m length cablebolts were used for long support. Continued production from adjacent drawpoints was maintained during the rehabilitation but two-way traffic in ESD-6L drive was not possible. A before and after rehabilitation comparison is shown in Figure 13, with the bulked and hummocky back removed and reshaped to a smoother arched back profile.

Figure 13. Pre and post rehabilitation comparison of L19 intersection rehabilitation. Both photos looking east towards EAC-7.

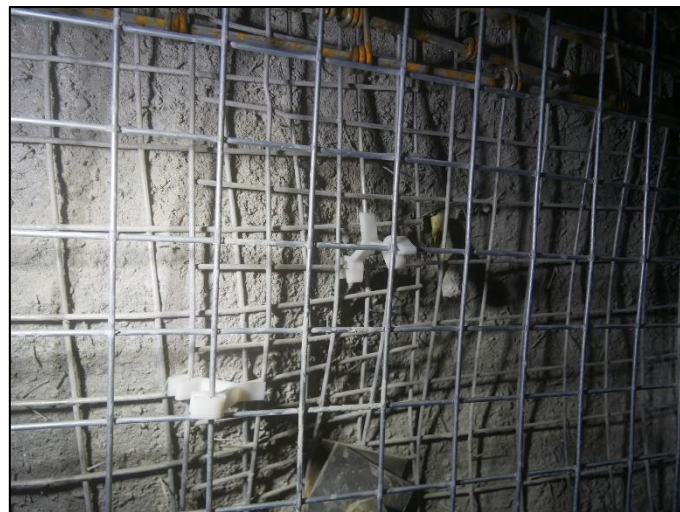
Figure 14. Plastic spacers used to hold a sheet of mesh in place to be sprayed over.

As part of the rehabilitation of the southern wall a novel technique for New Afton is being trialled using plastic spacers to embed an additional layer of welded wire mesh nearer to the inside skin of the sprayed fibrecrete cover. The objective is to reduce cracking and slabbing of the spray to cover by increasing its flexural toughness with increased embedded reinforcement per findings from Raffaldi et al (2018). An image of the spacers holding the additional reinforcement screen in place prior to spraying is shown in Figure 14.
