# New Afton Convergence Monitoring and Rehabilitation Planning in the B3 Footprint

**ABSTRACT:** New Afton's B3 block cave footprint has been in steady state production since 2022. During mining, the production footprint is subject to changing stresses that have been observed to cause squeezing and convergence of the drift profile at drawpoints and extraction drives. This can present challenges to the mining operations in terms of drift stability and accessibility of the footprint for equipment. Robust geotechnical monitoring practices have been developed to address this. Convergence is monitored using periodic visual inspections, LiDAR scanning, and multi-point borehole extensometers. These geotechnical monitoring activities generate data that requires interpretation and review during rehabilitation planning. Geotechnical monitoring data is assessed before, during, and after rehabilitation to understand the effectiveness of rehabilitation activities. This paper discusses two practical examples of New Afton's convergence monitoring and rehabilitation practices in the B3 footprint with the objective of documenting the importance of timely and well-planned rehabilitation in achievin

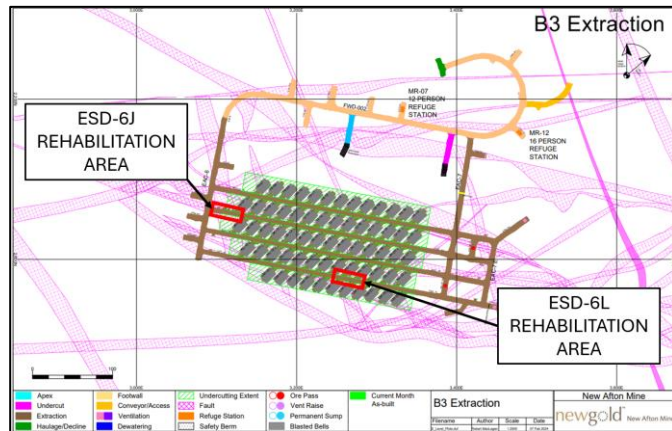
Figure 2. Layout of B3 extraction level with example areas of rehabilitation highlighted.

The B3 production footprint has a small and narrow geometry. It is approximately 125 m wide by 225 m long. There is a total of 65 drawbells and 111 drawpoints accessed via 4 extraction drives, as shown in Figure 2. Design production drift dimensions are 4.5 m wide by 4.3 m high for the extraction drives and drawbells.

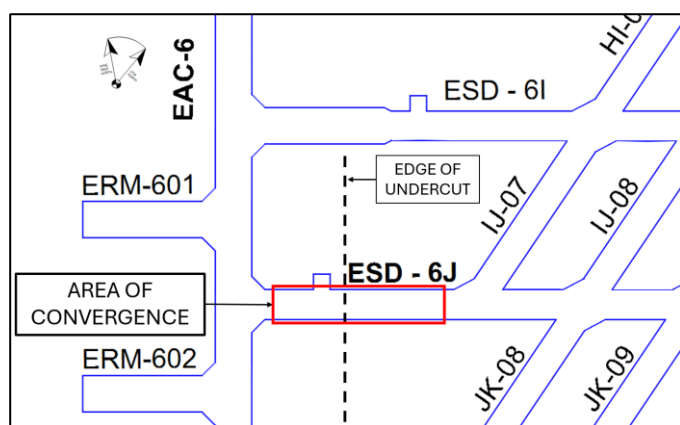
Figure 5. Highlighted location of ESD-6J convergence and subsequent rehabilitation. The approximate edge of the undercut level is indicated.

Extraction drive ESD-6J serves as an access to extract ore from the B3 production footprint into a remuck where it is hauled away by 45 tonne trucks. The entrance area of ESD-6J is situated on the outer edge of the caving footprint, and throughout the stages of the caving process it has experienced varying levels of mining induced stresses.

An electrical cutout in the northern wall was closed in January of 2022 due to convergence beginning to affect the electrical equipment contained within. The cutout was closed with concrete and long support was installed through the cured pour to add stability to the area. In February of 2022 the southern shoulder of ESD-6J entrance was showing damage caused by the convergence and scaled and re-supported with short support and an additional row of long support was installed. 9 m length 17.8 mm diameter cablebolts were selected to embed the cables into deeper, more competent ground prior to further movement.

- The nearest instruments in the north and south walls both showed a typical pattern of progressive, stress-driven bulking near the skin of the drift profile with relatively low depth of yield (<2.7 m) and low, steady rates of deformation (<1 mm per day).
- The nearest instrument in the back showed deeper seated yield up to 6.7 m depth and irregular movement rates of up to 1 to 2 mm per day.
- The nearest instrument in the back was damaged due to ground movement in May 2022.

Scaling and re-supporting of the back wedge was completed July 2023. The rehabilitation targeted only the wedge that had formed and leaving any areas that were intact and supported alone. This wedge was approximately 10-12 meters in length with the drive and spanned most of the width across the approximately 4 m wide drive. Approximately one meter of vertical height was gained through the scaling process, with the rehabilitation crew aiming to keep a smooth and arched profile in the back through the scaling and re-supporting process. Smaller wall sections that had been damaged through convergence and subsequent equipment damage from the tighter confines were scaled and re-supported as well. The floor was repoured, and production access was restored to the drive.
